Performance of masonry buildings during the 2011 Lorca earthquake

L. Hermanns, A. Fraile, E. Alarcón & R. Álvarez

Universidad Politécnica de Madrid, España

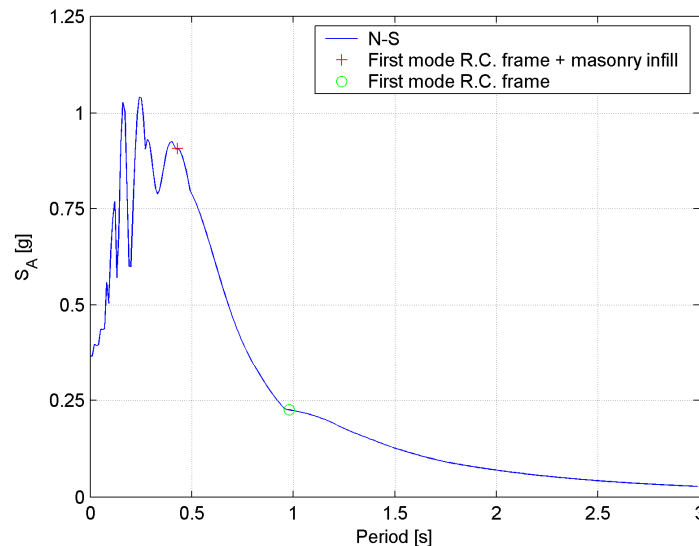
Figure 6. Response spectrum of the N-S component of the 2011 Lorca earthquake

The reduction in period increases the base shear force by a factor of 3. The majority of the base shear force is taken by the masonry wall corresponding to its contribution to the overall stiffness. In this particular example the shear wall at ground level takes approximately 2.8 MN i.e. 2/3 of the total base shear force. The resulting average tangential stresses are higher than 4 N/mm² exceeding clearly the

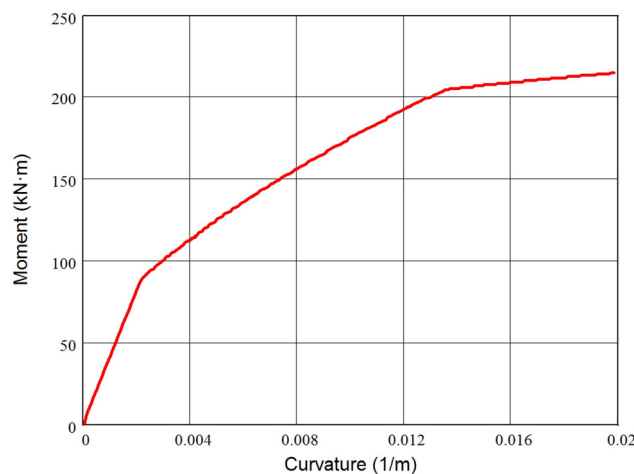
Figure 7. Moment-curvature diagram of the compressed column

The maximum value reaches 215 kNm. Based on equilibrium considerations of the capacity design method, see Figure 8, and considering a floor height h of 4 m, the corresponding maximum shear force is 107.5 kN.

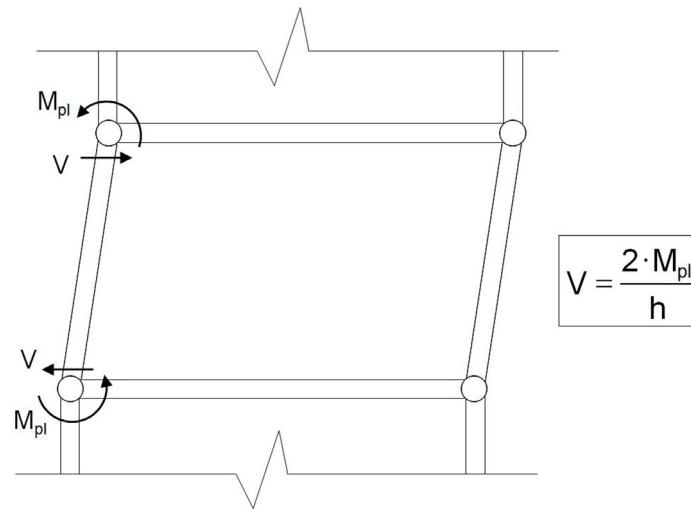
Figure 8. Estimation of the shear demand in a column

The shear capacity of this column without shear reinforcement is according to the Spanish Seismic Design Code (NCSE 2002) 182.5 kN. Considering the same limit values for the maximum moment and the shear capacity of the column a floor height of 2.36 m would be necessary to increase the shear demand to an extent that the shear capacity is exceeded when reaching the maximum moment. However, this floor height is much lower than the limit value established by the urban building standards. This means that, in general, a column shear failure may be avoided if the capacity design approach is followed and properly detailed shear reinforcement is designed and provided. In the following section the interaction between frame structure and infill panels will be further discussed.

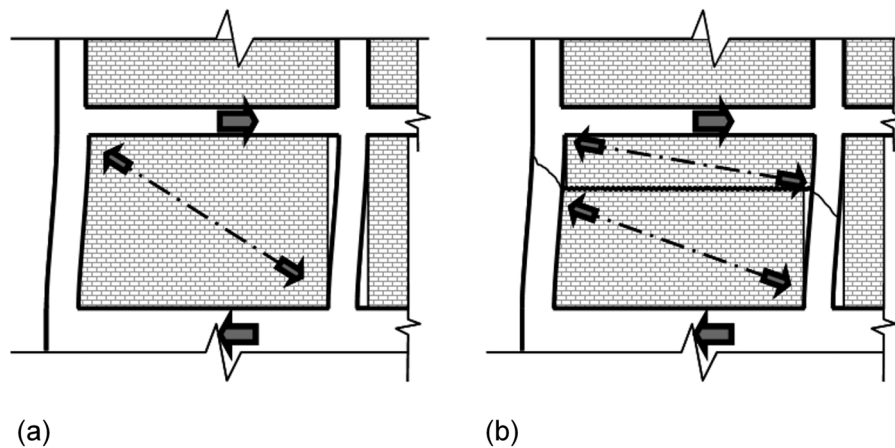
This type of failure is particularly dangerous because of the damage that is caused to the compression zone of the infill panel i.e. the load carrying strut in an equivalent strut model. If the failure results in the formation of two struts like indicated in Figure 11 b important forces act on the column sections almost at mid-floor height.

The formation of two struts may be favoured by the existence of conduits, openings or other discontinuities in the infill panel.

Figure 11. Force transmission before (Fig. 11 a) and after (Fig. 11 b) shear failure of the infill panel
